# Floating photovoltaic systems: photovoltaic cable submersion and impacts analysis

The problem under study is related to the potential submersion of photovoltaic cables, that can lead to a degradation of its electrical insulation capabilities and, consequently, higher energy production losses and water contamination.

The results showed that the submersion of photovoltaic cables with rubber sheath in saltwater can lead to a cable accelerated degradation, with reduction of its electrical insulation and, consequently, copper release into the aquatic environment.

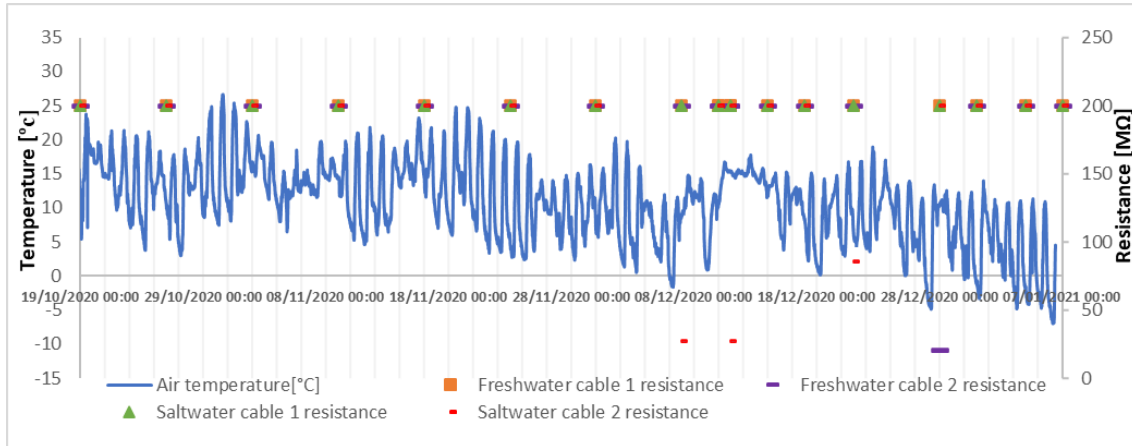
Figure 7 Air temperature and electric insulation resistance over time.

In the first measurement, all cables reached the maximum measurement limit of the device, 200 M $\Omega$ . The first cable to record electrical insulation losses was cable 2, in salt water in the eighth week, with a resistance value of 27 M $\Omega$ , and in the same week the presence of copper was detected with a significant concentration (Table 3). This decrease in the resistance value occurred when the air temperature dropped below 0°C for the first time in that year, as showed in Figure 7. The cable 2 (saltwater) presented again resistance values below 200 M $\Omega$  during the test period, nevertheless these resistance values were higher than 2.9 M $\Omega$ , the minimum insulation resistance value for a 4 mm<sup>2</sup> cross-section cable. Cable 2 (freshwater) had also a one low resistance value, recovering to a higher value the next week. The cable 1, either submerged in freshwater, either in saltwater, never presented lower electrical resistance values.
